CORNER RECORD

Document Number CR 3507

City of LIVERMORE

Brief Legal Description STREET MONUMENT LOCATIONS

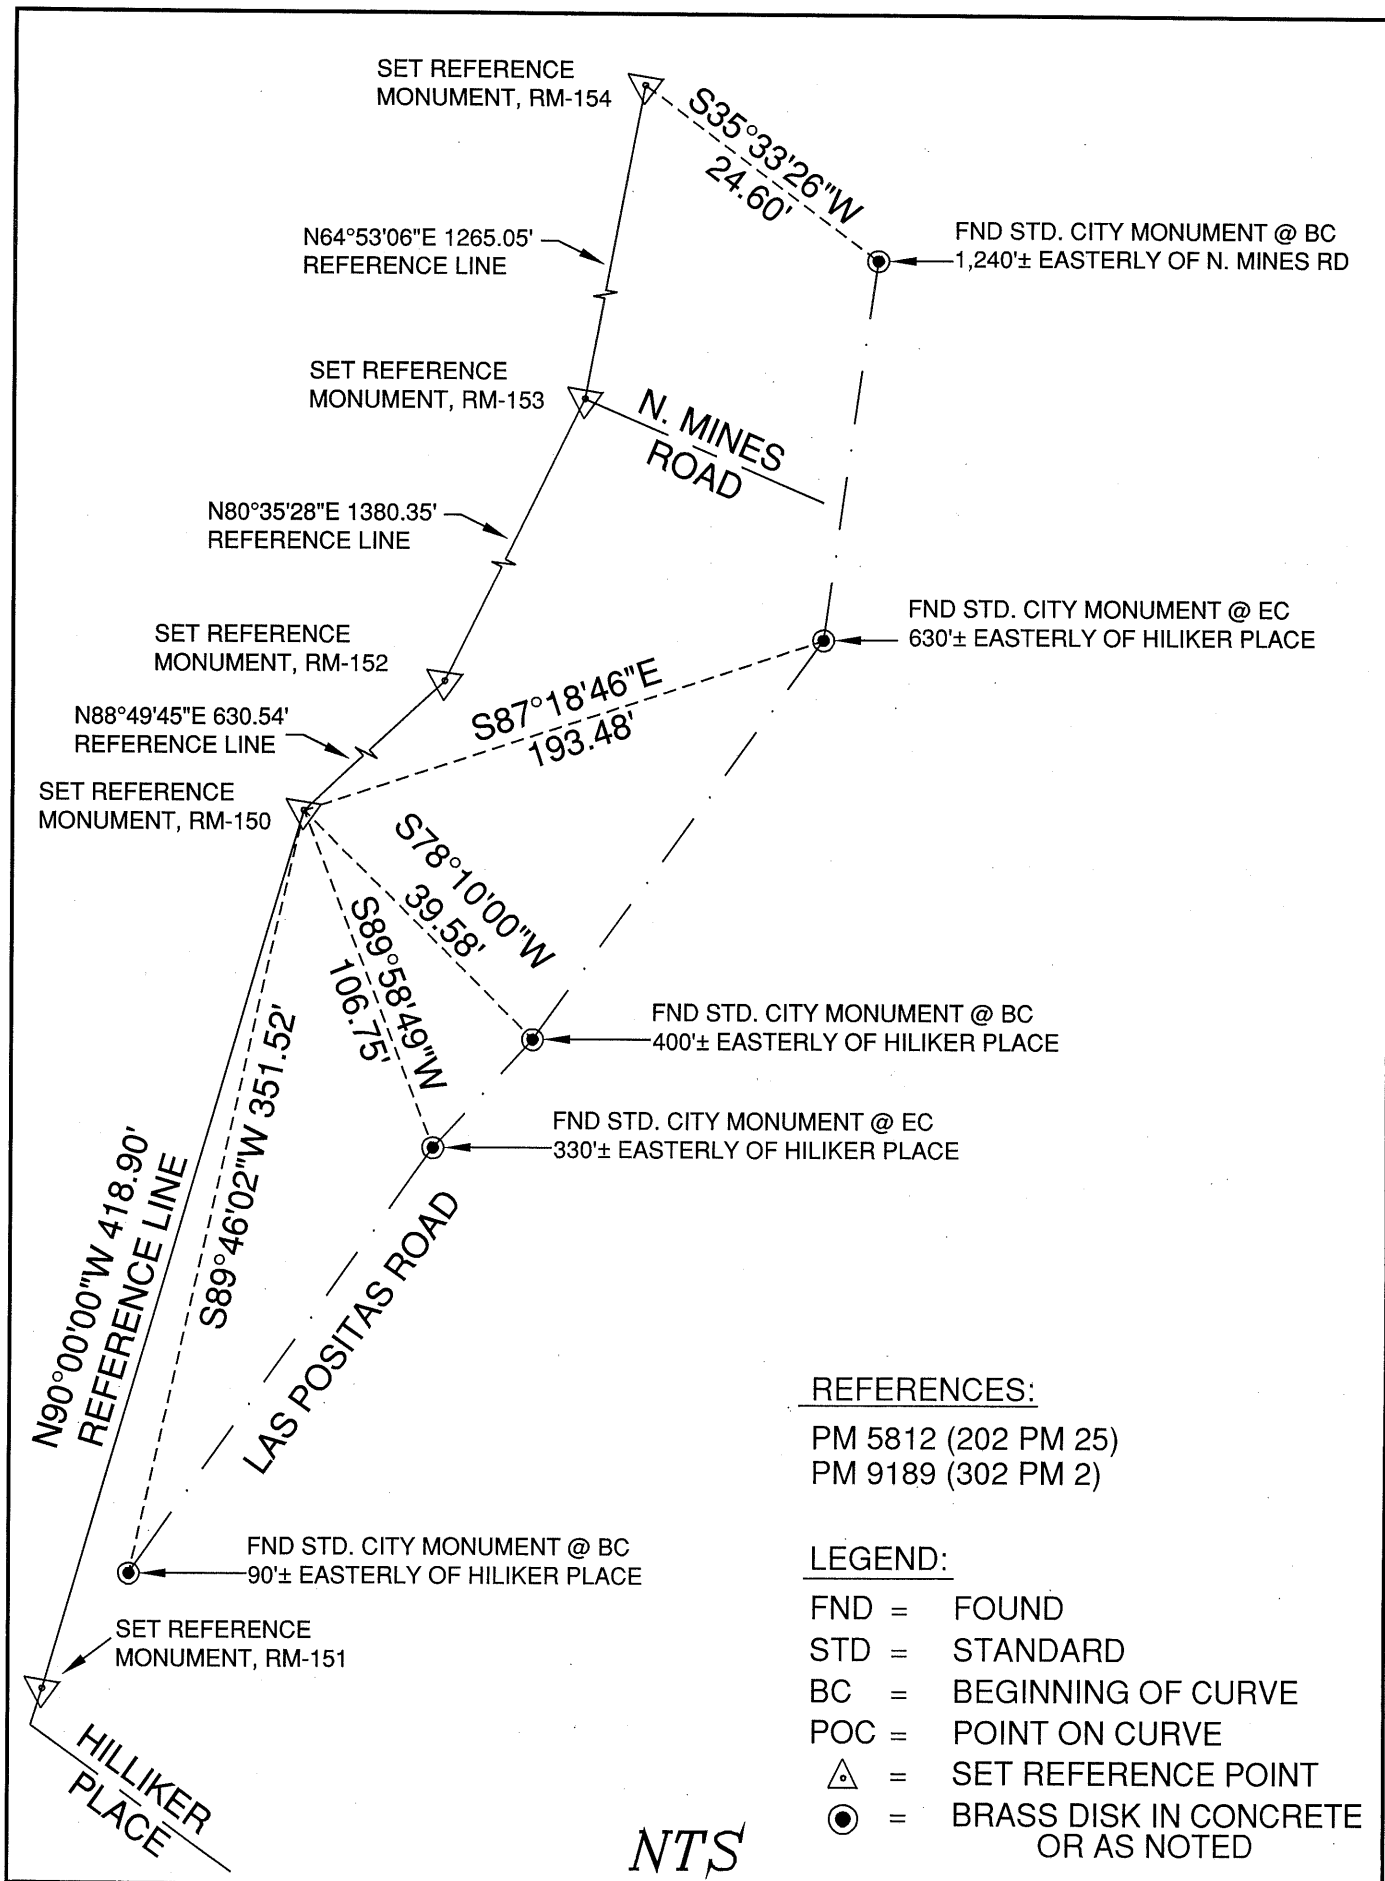
Identification and type of corner found: Evidence used to identify or procedure used to establish or reestablish the corner: STANDARD STREET MONUMENTS ALONG LAS POSITAS ROAD, LIVERMORE, CA

LOCATED BY ESTABLISHING A REFERENCE LINE IN AN AREA NOT TO BE EFFECTED BY CONSTRUCTION

A description of the physical condition of the monument as found and as set or reset: MONUMENTS FOUND WERE STANDARD WELL MONUMENTS IN GOOD CONDITION WITH A BRASS DISC AND PUNCH MARK.
